THE NAVAL AVIATION MAINTENANCE SAFETY REVIEW

*A Naval Safety Center Publication*

*Winter 1973*

## ONE UP, ONE DOWN, TOO BAD

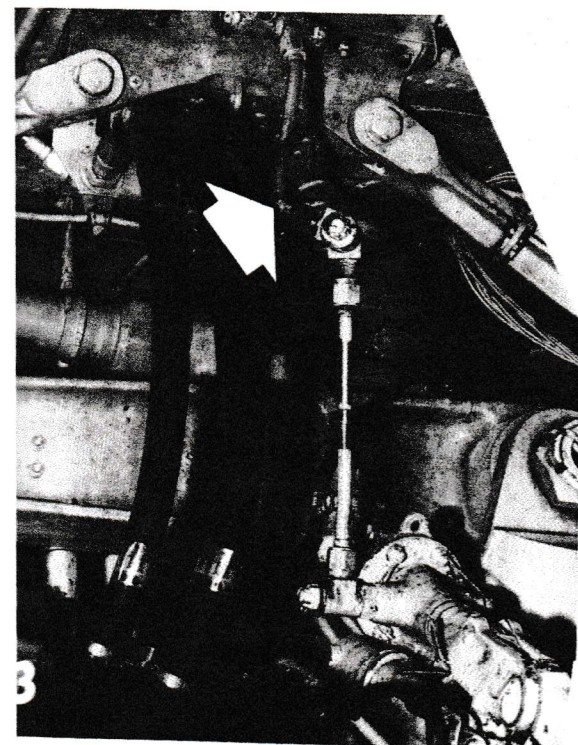
Original Murphy

twisted and crimped line due to Murphy (reverse) installation.

A visual inspection of the starboard wheelwell of the salvaged aircraft revealed the swing joint tube assembly for the main gear strut was twisted, crimped and cracked (see Photo 3). The aircraft was placed on jacks and hydraulic pressure applied up-stream to the swing joint. The over-center downlock would not release. The swing joint was then bypassed and hydraulic pressure was applied directly to the downlock actuator; the downlock released normally.

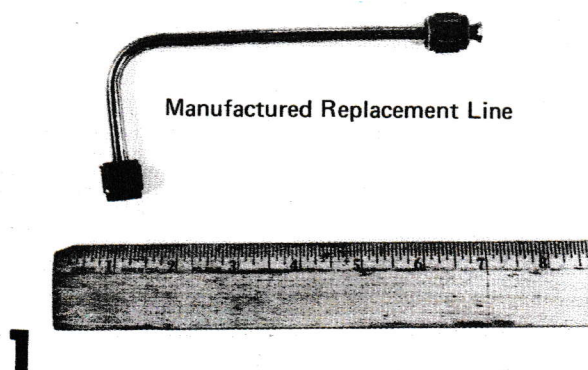
Shortly after the aircraft had launched, an airframes man approached the maintenance control CPO with the manufactured hydraulic line (see Photo 1) and inquired as to the whereabouts of the aircraft. After checking the VIDS board, the CPO ascertained that the hydraulic line may have been missing from the aircraft and notified the squadron duty officer of the situation.

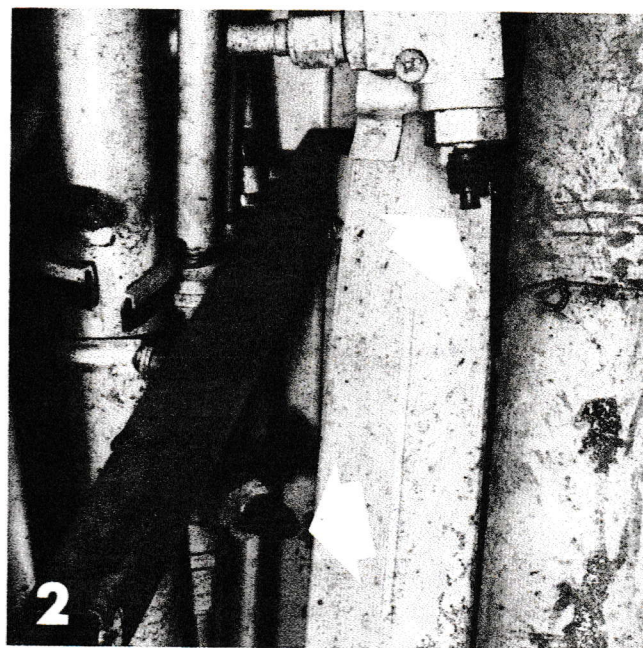
Arrows indicate capped off connectors where line was removed.

After salvage of the aircraft, the port main landing gear was extended to the down-and-locked position by relieving the pressure from the up side of the gear hydraulic actuating cylinder. A visual inspection of the wheelwell verified the subject line was in fact missing and the hydraulic fittings capped off (see Photo 2).

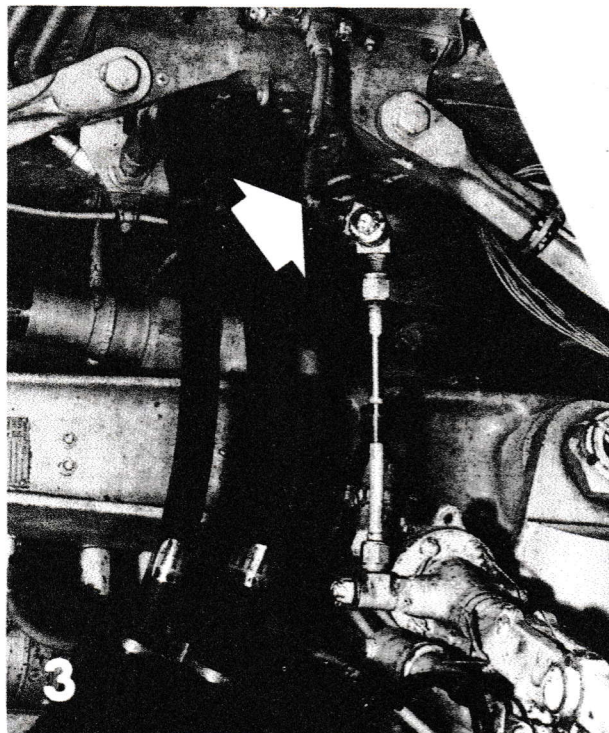
Twisted and crimped line due to Murphy (reverse) installation.

A visual inspection of the starboard wheelwell of the salvaged aircraft revealed the swing joint tube assembly for the main gear strut was twisted, crimped and cracked (see Photo 3). The aircraft was placed on jacks and hydraulic pressure applied up-stream to the swing joint. The over-center downlock would not release. The swing joint was then bypassed and hydraulic pressure was applied directly to the downlock actuator; the downlock released normally.

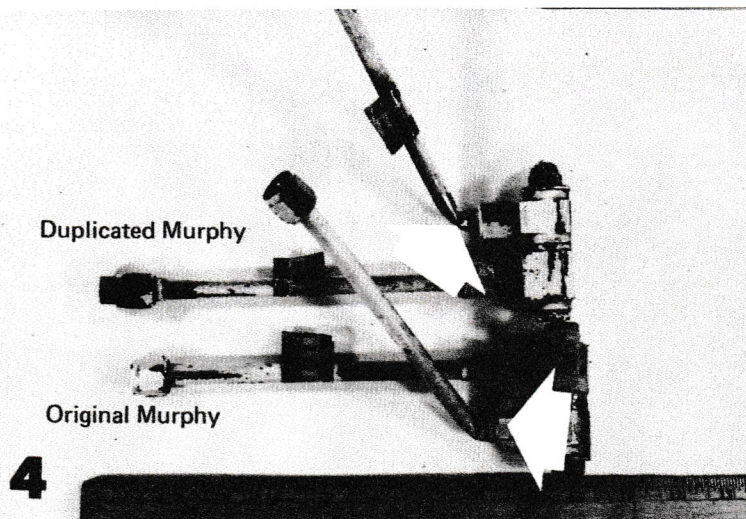
To further clarify the situation, another aircraft was then drop checked with the apex of its swing joint installed in the forward position. The gear retracted and extended normally, however, it would not retract when recycled. The swing joint assembly was found deformed identically to that of the line found on the crashed aircraft (see Photo 4).
